# **SECTION 206: FLOOD PLAIN MANAGEMENT ASSISTANCE**

## **HISTORICAL ICE JAM FLOODING IN MAINE, NEW HAMPSHIRE AND VERMONT**

**New England Division**

**OCTOBER 1980**

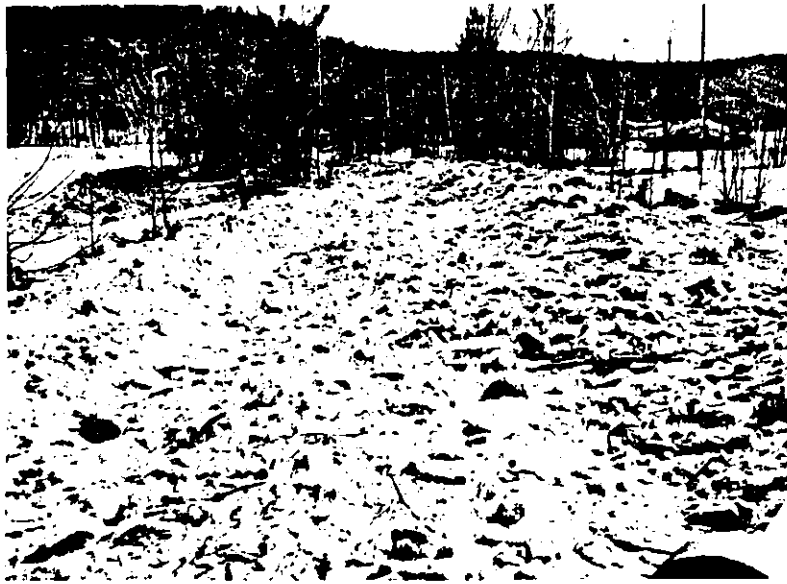
Chester, Vermont - Williams River, Jammed  
ice downstream of Rout 103. (February 1976)

Chester, Vermont - Williams River.  
Dragline removes jammed ice downstream of Route 103 -  
see figure 1. (February 1976)

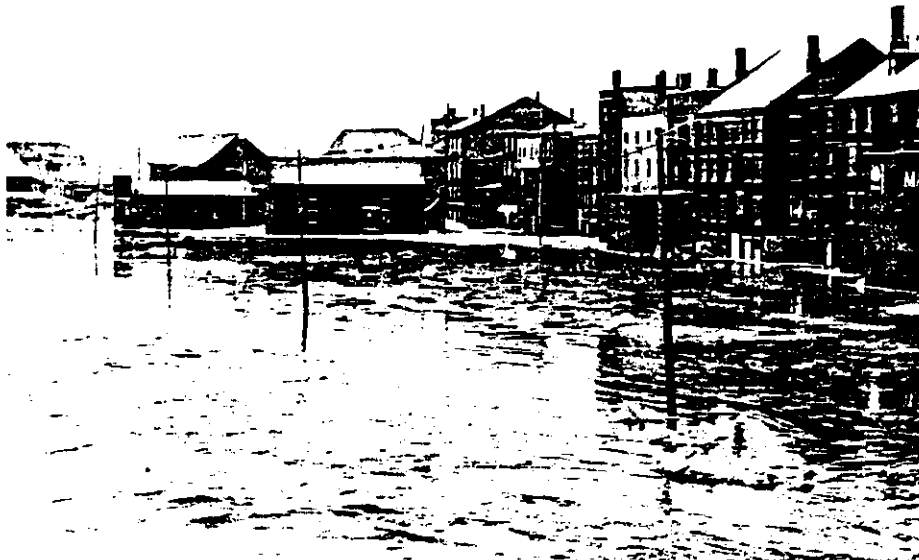
Gardiner, Maine - Cobbosseeconte Stream. Backwater flooding caused by an ice jam downstream on the Kennebec River. (January 1978)

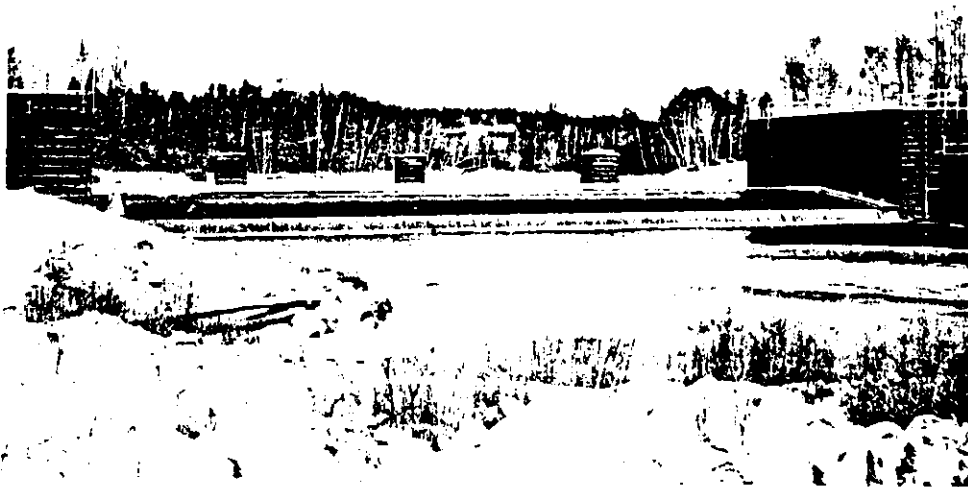
Cherryfield, Maine - Narraguagus River. View from  
downstream. The 3 piers prevent ice floes from moving  
downstream.

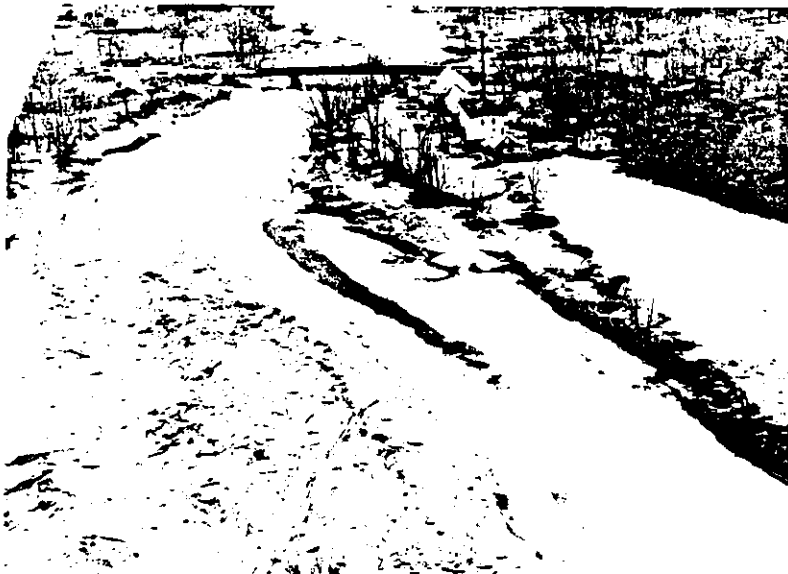
Farmington, Maine - Sandy River. Several days after dusting, the solid ice cover has melted. (April 1970)

Dusting refers to the spreading of a dark substance on an ice surface. The principle behind this method is that the dark material attracts and retains the sun's heat and therefore, increases the melting rate of the ice. This technique is more of a preventive measure than a solution to actual ice jams. Dusting is usually only effective on river sheet ice as a safeguard against the formation of ice jams in the future (see figure 4). A disadvantage of dusting is that narrow or sinuous streams are not easily covered aerially. A second problem is weather, cloudy weather slows down the melting process and even a slight dusting of snow will almost entirely negate the dusting effort.

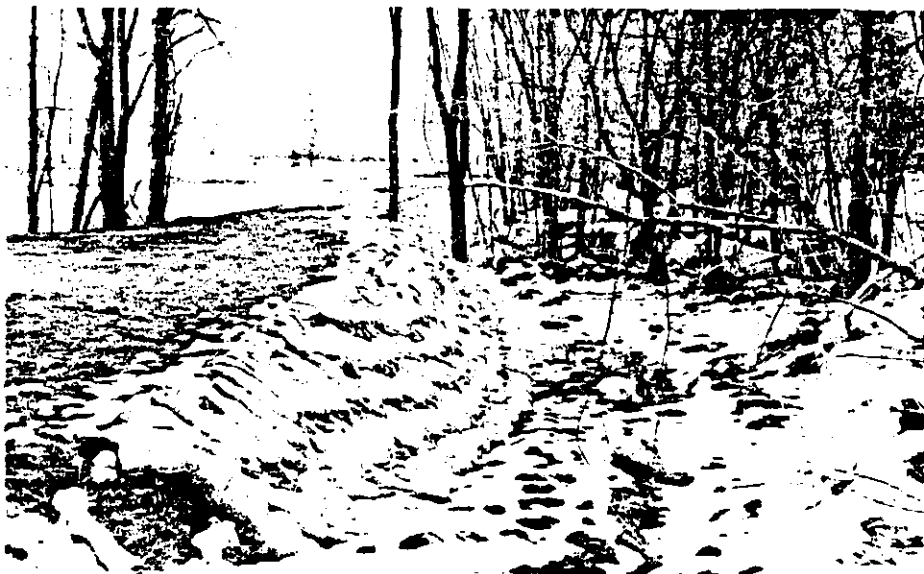
Farmington, Maine - Sandy River. Sand bags are used to protect a temporary roadway. (April 1970)

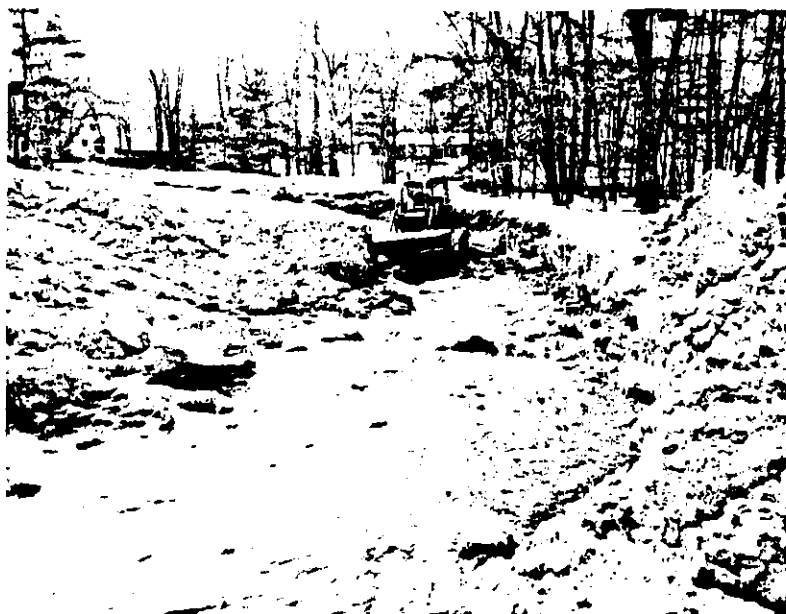
Chester, Vermont - South Branch Williams River. Shovel loader clears ice jam downstream of Route 103. (February 1976)

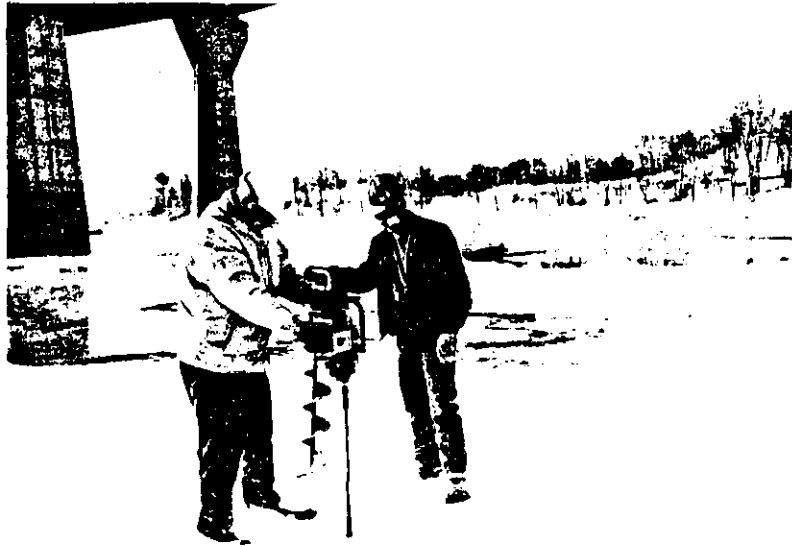
Hartford, Vermont - Connecticut River. Holes drilled in ice for the placement of charges. (March 1970)

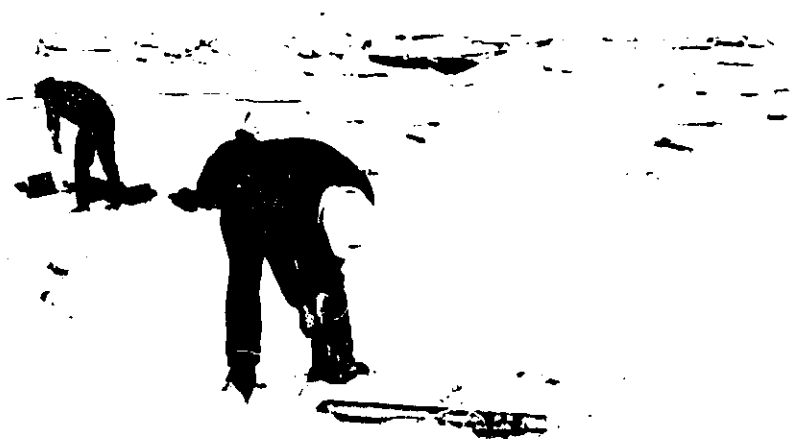
Placement of charges below the ice cover.

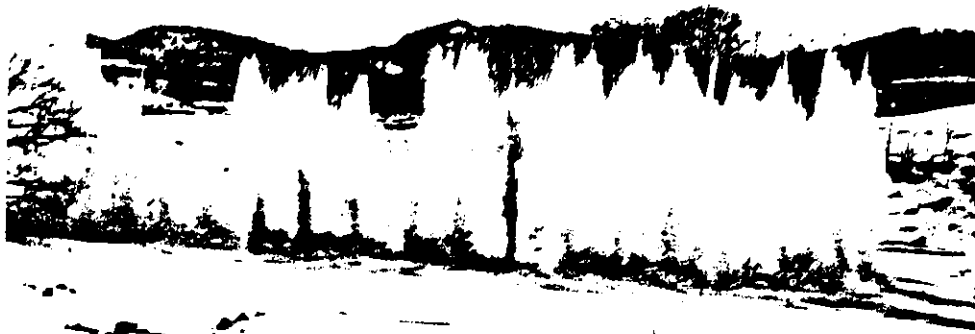
Hartford, Vermont - Connecticut River. Detonation of a line of explosives.

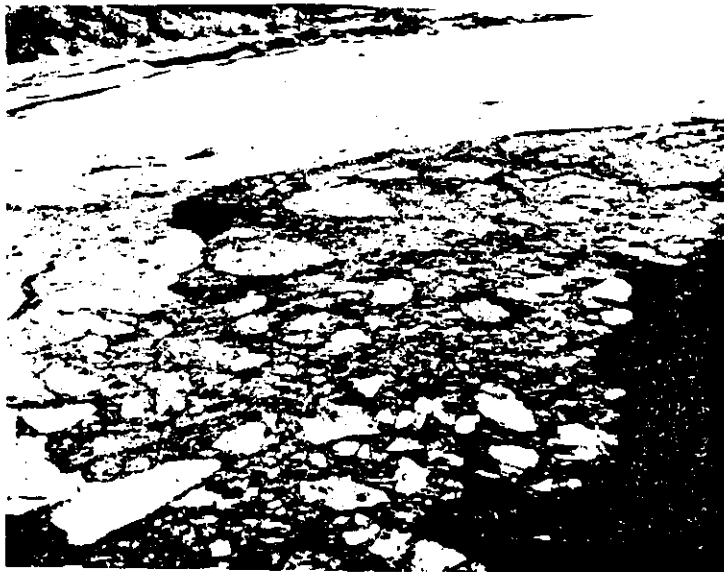
Broken ice moving downstream after explosion.

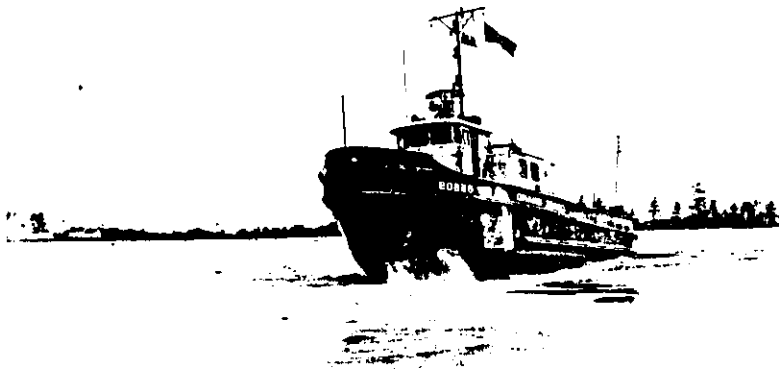
Richmond, Maine - Kennebec River. Coast Guard ice breaker breaking solid ice cover. (February 1970)

Due to channel depths of most streams and a lack of necessary ships, ice breakers have been used on a limited basis in New England. Ice breakers are most effective when breaking sheet ice and their capability in breaking jammed ice is suspect. The use of ice breakers is a slow, expensive process and other options should be explored before employing ice breakers (see figure 9).

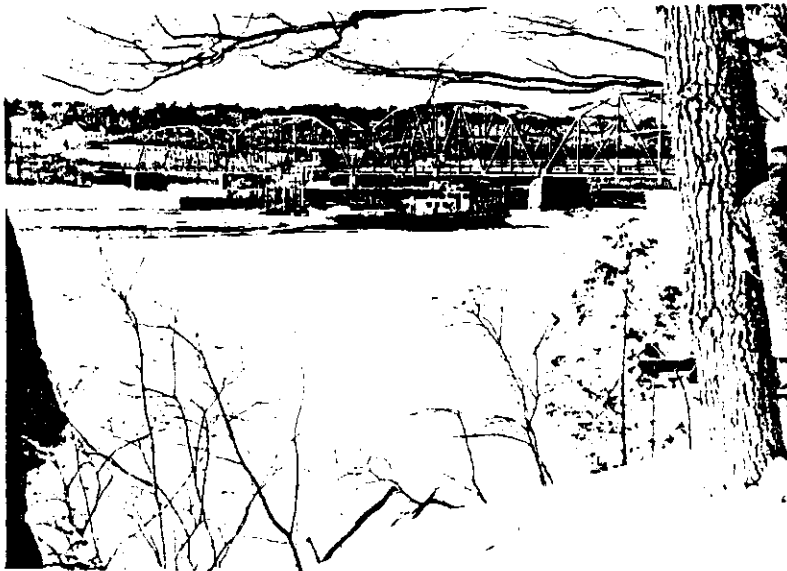
Richmond, Maine - Kennebec River. Coast Guard ice breakers breaking ice at Richmond/Dresden Bridge. (February 1970)

The piers of the bridge cause the ice to back up, creating a jam which extends upstream for approximately 2 miles. Coast Guard ice breakers also break up this jam, however, the ice only moves 1-1/2 miles downstream until it jams again at Little Swan Island. Downstream of Little Swan Island, the Kennebec flows freely into Merrymeeting Bay.
